PND No. 084074.10

RE: Harper Dock – Future Planning

The following letter provides a discussion on the potential operations of Harper Dock as a function of future repairs or replacement of the facility. This work effort is in response to Task 10 of our on call services agreement and follows a meeting with the Port, Makers Architects and PND where we preliminarily presented potential scenarios for the future. We understand that this is a public access dock and that no commercial use or heavy load public requirements need to be considered. We have taken into account known permitting issues, upland constraints and budget considerations in development of the concepts.

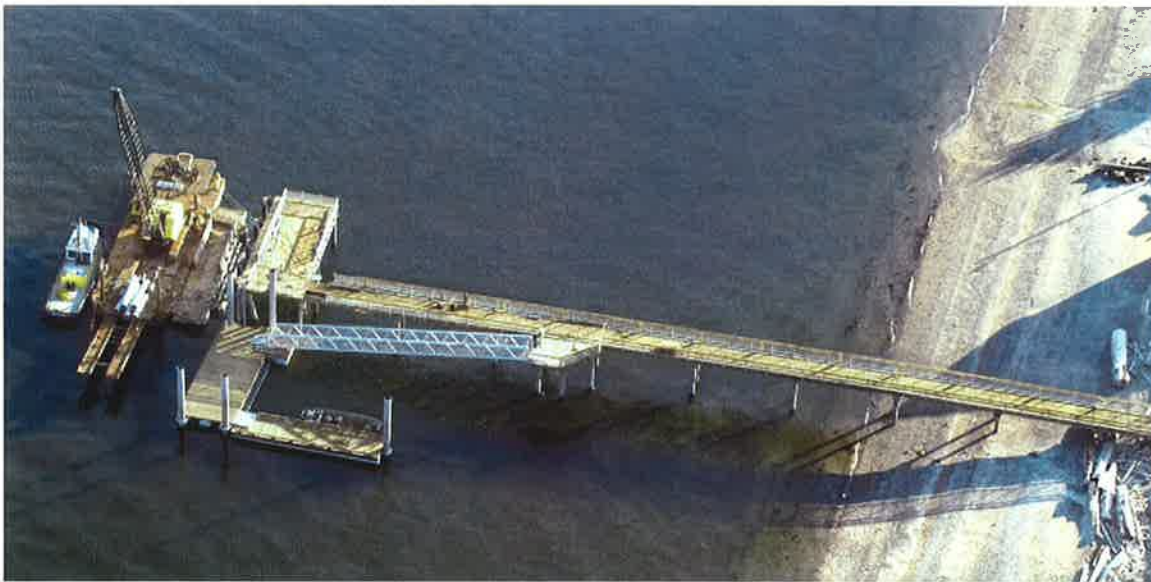
This obviously becomes cost effective because of the better use of the pile capacity and strength combined with a long span steel structure. Slightly more expensive would be using long span timber stringers as seen at the NWMC in Port Townsend. (Picture below.)

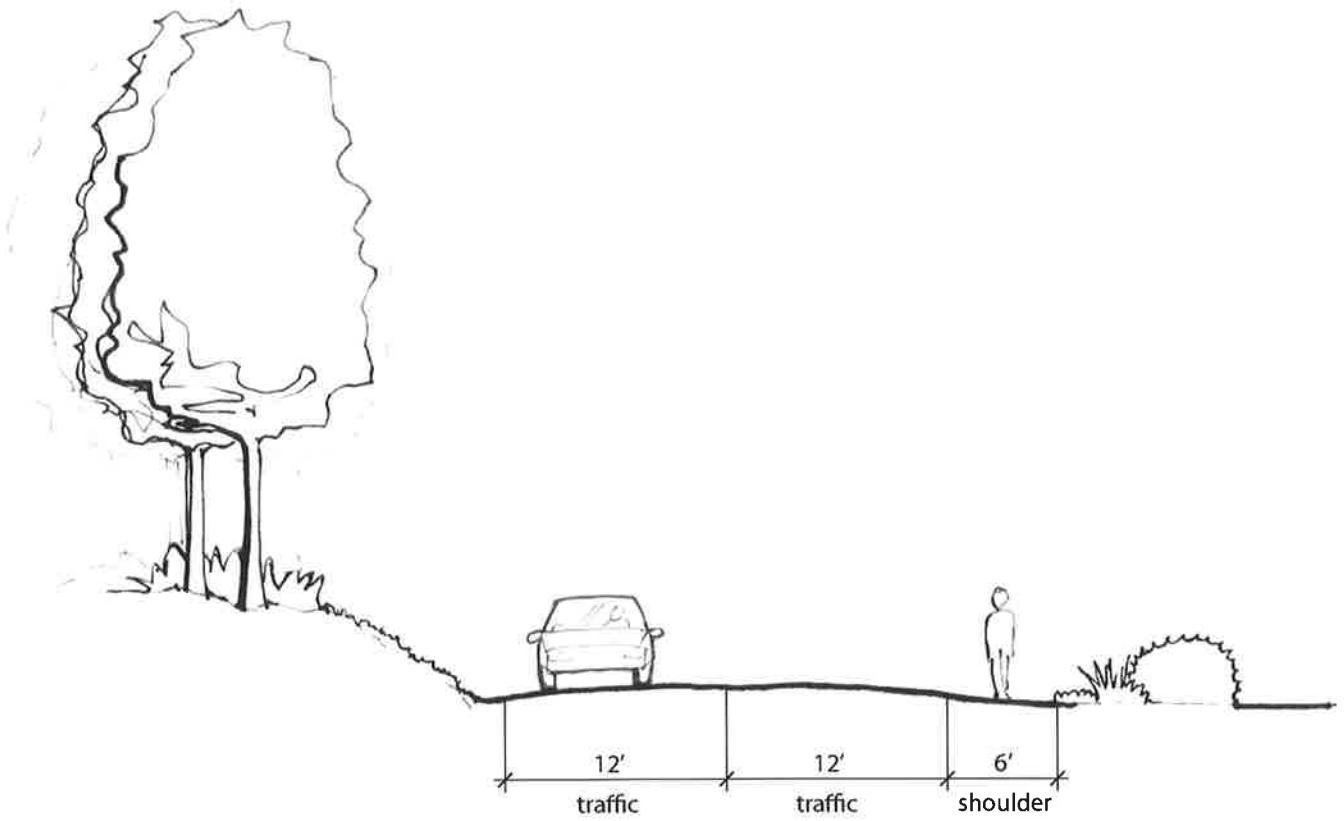
SE Southworth Dr Section - facing west

requirements. We also provided some alternative ideas on how the upland might be upgraded and then the potential for enhancement of the roadway so that safer public access from the county road could be realized. (See attachments.)

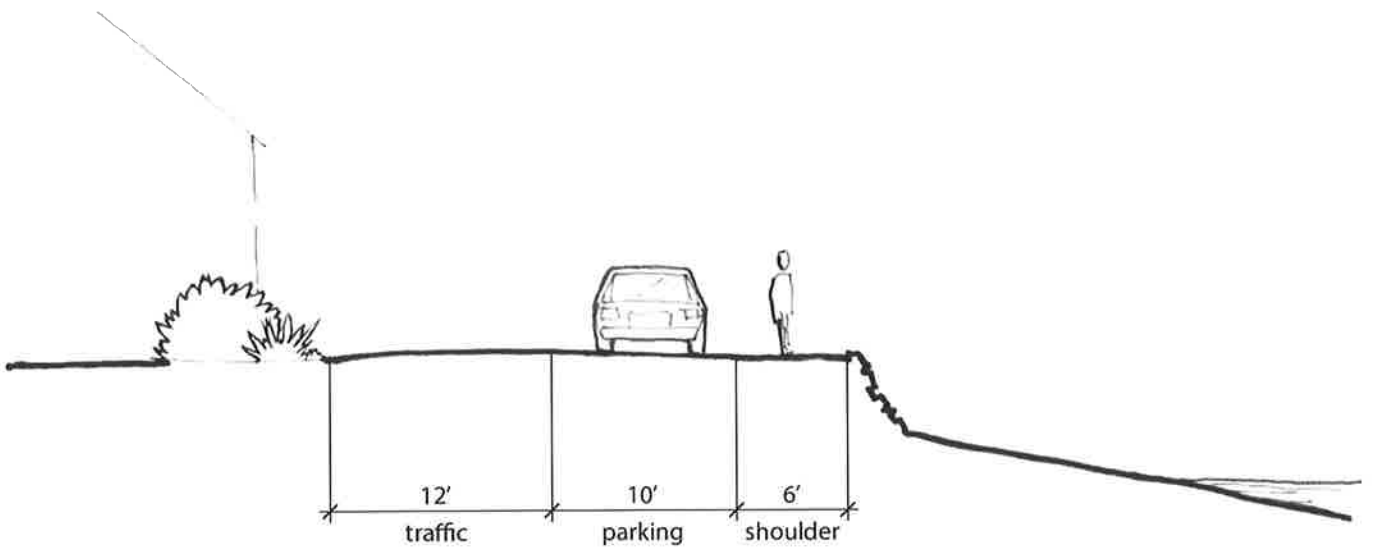
SE Cornell Rd Section - facing north
