**PHASE II ENVIRONMENTAL  
SITE ASSESSMENT  
BAY STREET PROPERTY  
521 & 525 BAY STREET  
PORT ORCHARD, WASHINGTON**

Project No. 104-21018  
April 27, 2021

Prepared for:  
Mr. Arne Bakker  
Port of Bremerton  
8850 SW State Highway 3  
Bremerton, Washington 98312

Prepared by:  
Krazan & Associates, Inc.  
1230 Finn Hill Road NW, Ste A  
Poulsbo, Washington 98370  
(360) 598-2126

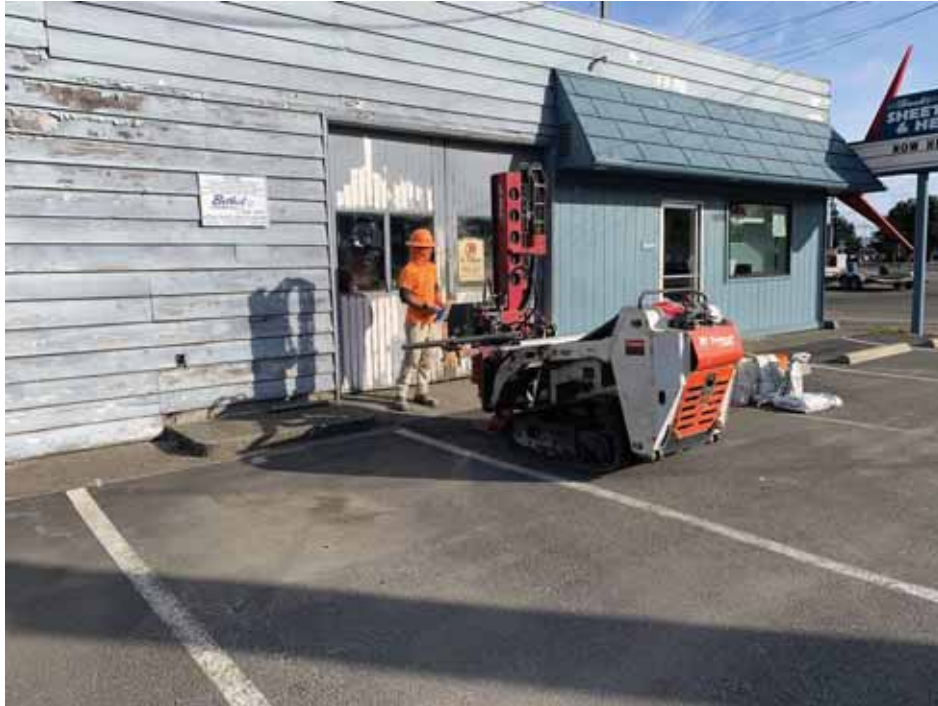
**Photo 1:** Subject Site – View showing vapor probe location VP-1 in front of 525 Bay Street. This location is adjacent to in place USTs.

Vapor from probe VP-1 located near boring B-2 at 525 Bay Street exceeded the MTCA Method B Sub-Slab Soil Gas Cancer and Noncancer Screening Levels for all APH criteria, as well as for benzene and m,p-xylenes. Vapor from probe VP-2 located at 521 Bay Street exceeded the MTCA Method B Sub-Slab Soil Gas Cancer and Noncancer Screening Levels only for benzene.

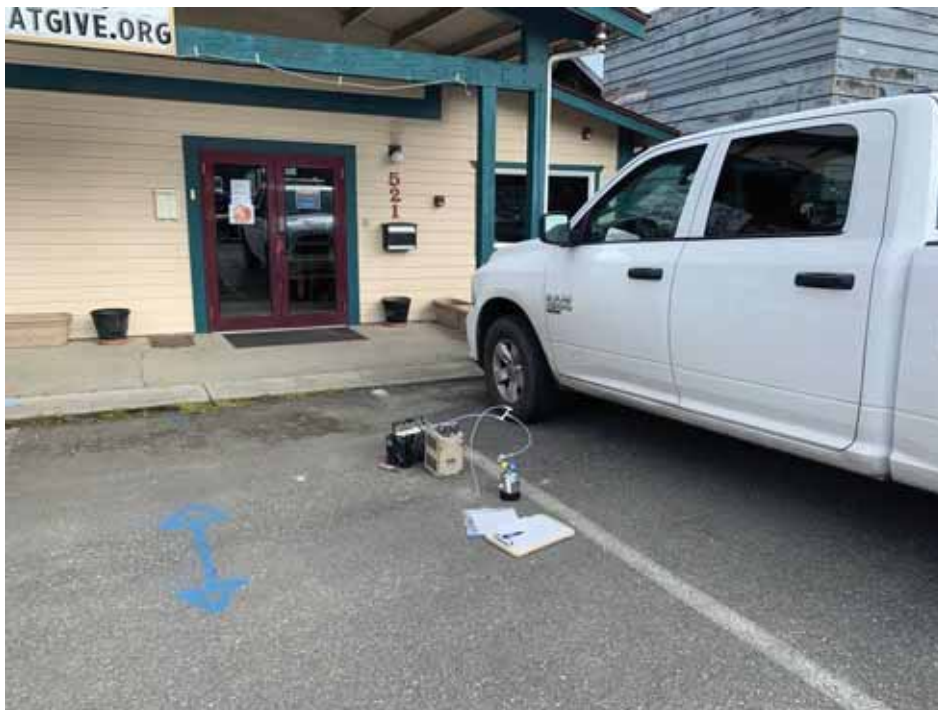
**Photo 2:** Subject Site – View showing vapor probe location VP-2 in front of 521 Bay Street. This photo shows the sampling set-up.

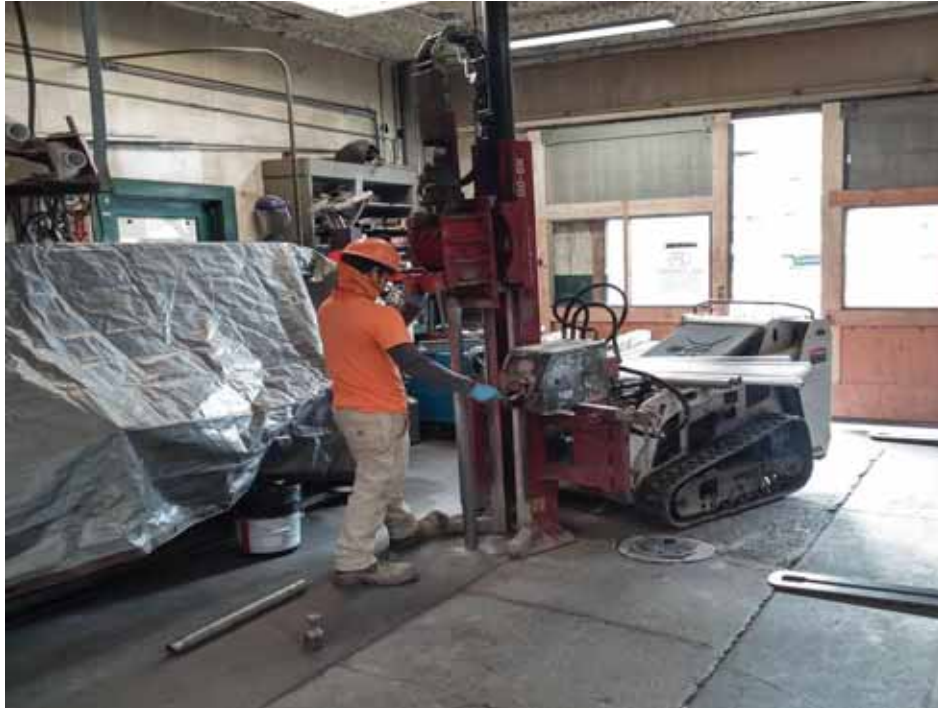
**Photo 3:** Subject Site – View showing soil boring location B-1 inside 525 Bay Street. This is located adjacent to the underground lift.

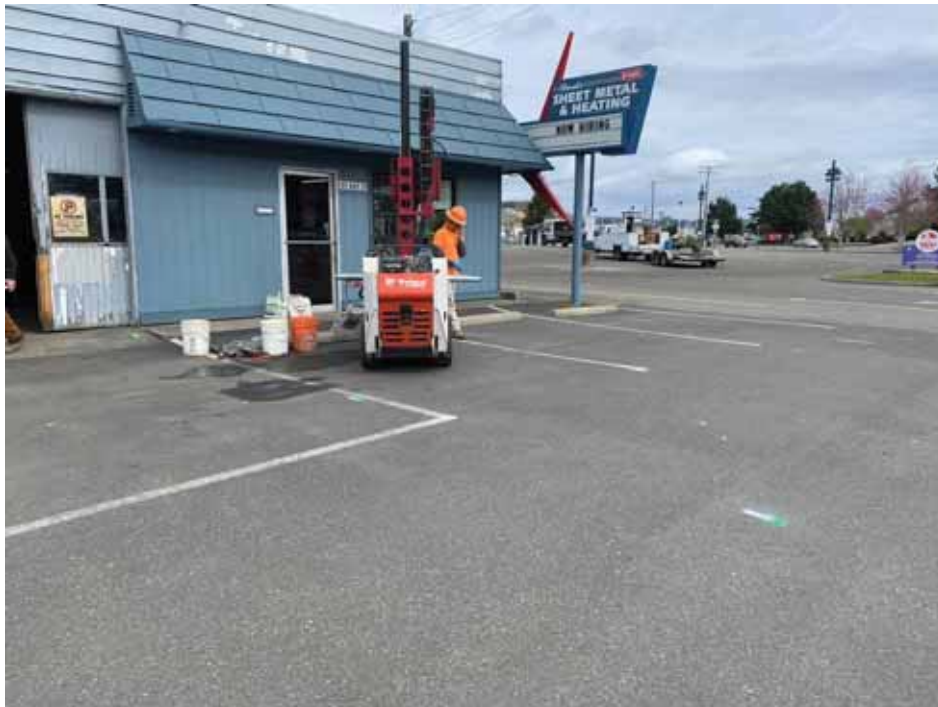
**Photo 4:** Subject Site – View showing soil boring location B-2 in front of 525 Bay Street. This boring was located near the former pump island and adjacent to previous borings.

Soil in boring B-2 adjacent to the closed-in-place USTs at 525 Bay Street exceeded the Model Toxics Control Act (MTCA) Method A soil cleanup levels for unrestricted land uses for gasoline-range TPH and benzene at depths of 5 and 9 feet. Soil in the vapor boring VP-1 adjacent to boring B-2 also exceeded the MTCA Method A soil cleanup level for unrestricted land uses for gasoline-range TPH at a depth of 5 feet. Similar conditions were documented adjacent to the tanks during the assessment conducted in 2000. Soil in boring B-4 adjacent to the removed UST at 521 Bay Street exceeded the MTCA Method A soil cleanup levels for unrestricted land uses for gasoline-range and diesel-range TPH at a depth of 5 feet.

Groundwater in boring B-2 adjacent to the closed-in-place USTs at 525 Bay Street exceeded the MTCA Method A cleanup levels for gasoline-range TPH and benzene at a depth of 10 feet. Groundwater in boring B-5 adjacent to the closed-in-place UST east of the building at 525 Bay Street also exceeded the MTCA Method A cleanup level for gasoline-range TPH at a depth of 10 feet. Groundwater in boring B-4 adjacent to the removed UST at 521 Bay Street exceeded the MTCA Method A cleanup levels for gasoline-range and diesel-range TPH at a depth of 10 feet.

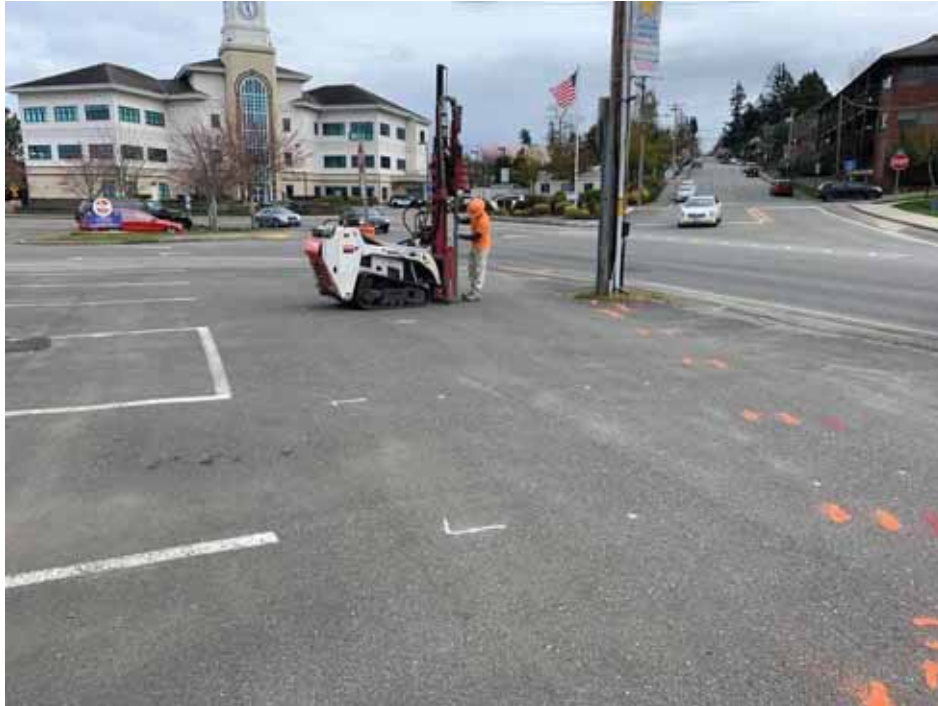
**Photo 5:** Subject Site – View showing soil boring location B-3 adjacent to Bay Street.

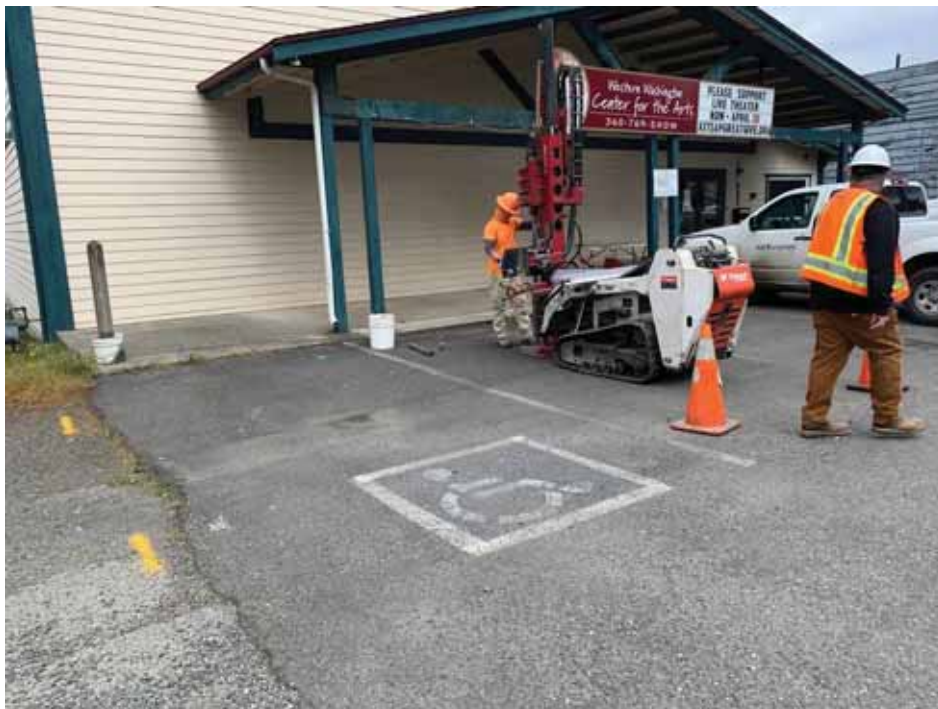
**Photo 6:** Subject Site – View showing soil boring location B-4 in front of 521 Bay Street. This was located near the location of the former heating oil UST.

- Diesel & gasoline in the groundwater around the former heating oil UST at 521 Bay Street were a degree of magnitude higher than the results from the 2002 investigation and UST removal, indicating a later impact from a potential gasoline plume. The elevated diesel result indicates that not all of the impacted soil was excavated in 2002.

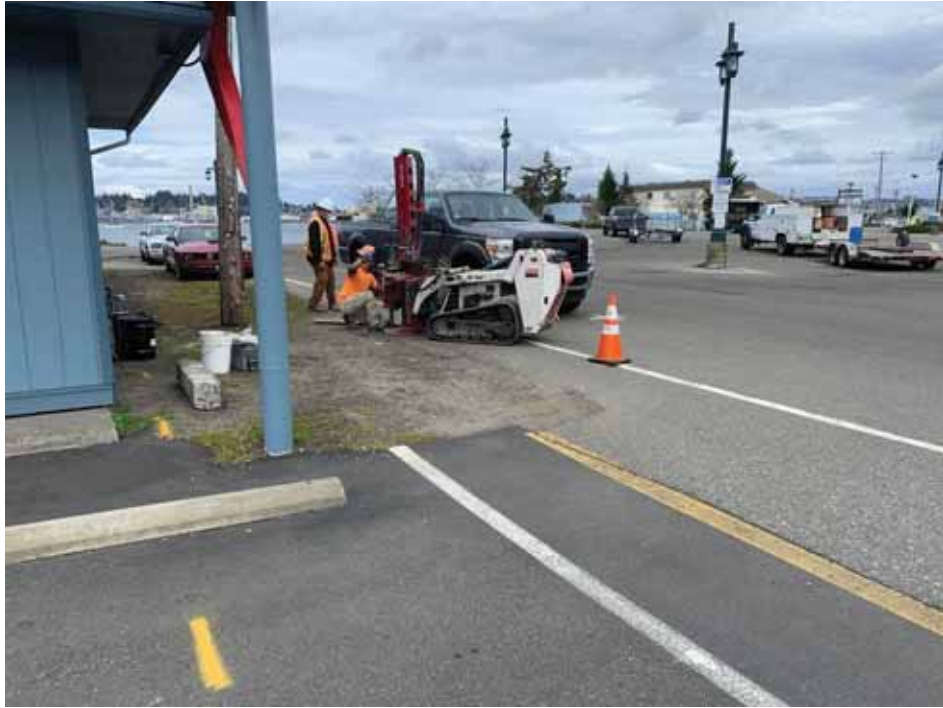
**Photo 7:** Subject Site – View showing soil boring location B-5 on the north side of 525 Bay Street. This was located near a potential in-place UST.

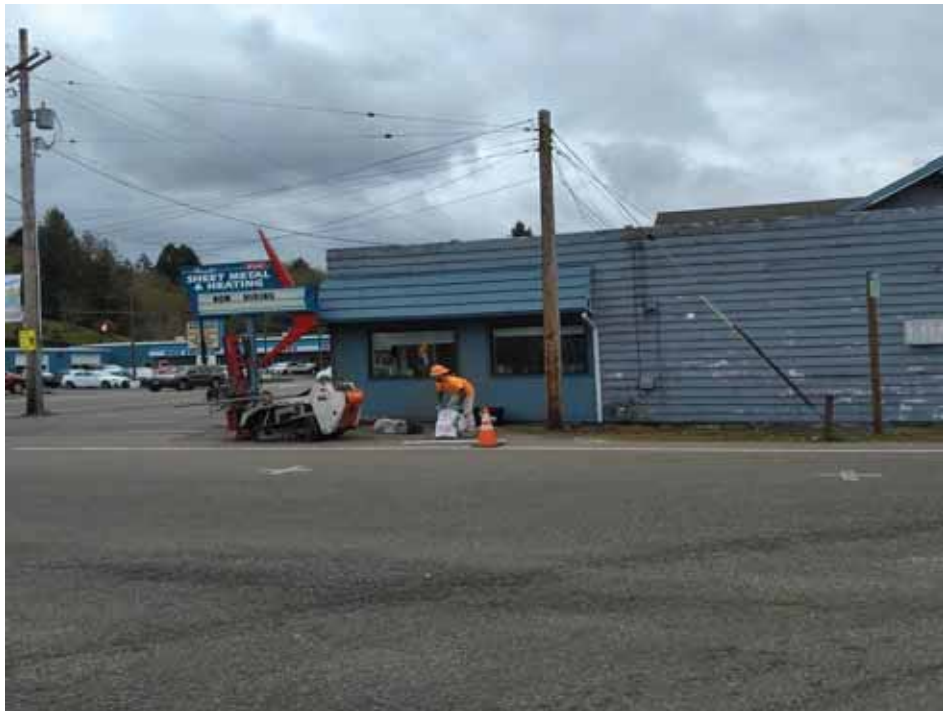
**Photo 8:** Subject Site – View looking south showing soil boring B-5.
